# Richmond Refinery LPS Bulletin – Reliability

## Pipe Coating Failure at High Temperature

IMPACT ERM ID: 9478

**Location:**  
**Distillation & Reforming West**

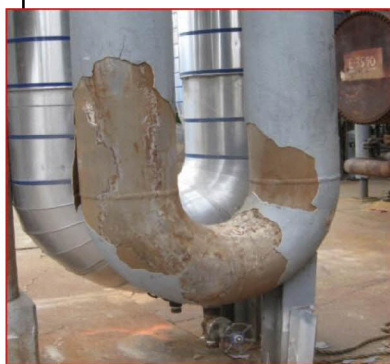
Coating Insulation Flaking off of Pipe

Delta Industrial Thermal Insulating Coating (by MASCOAT) was applied on process piping in lieu of 2" standard Calcium-Silicate insulation material. Spikes in operating temperature during regeneration resulted in the coating failure.

1. New insulation material (Delta Industrial Thermal Insulating Coating) was added to the pipe in May 2009 and it flaked off (failed) in Feb 2011 when higher temperatures exceeded the manufacturer's recommended 400°F temperature limits for two weeks during REGEN.
2. No MOC was initiated by Project Group nor ABU for the replacement of insulation not-in-kind (which was required by RI-370 Management of Change Process).
3. The Plant experiences higher than normal temperatures during plant shutdowns and start-ups (especially during regeneration phases).

1. Design & Engineering (Management of Change): Add step to the CUI Project Master Guidelines (procedure) for recommendations for pilot studies of new materials to ensure/require the initiation of the Management of Change Process (RI-370) prior to implementing any changes not-in-kind.
2. Design & Engineering (Chemical Selection and Substitution): Path forward for piping with failed Standard MT-DTI coating is to re-insulate such piping with the prior standard 2" Calcium-Silicate insulation.
3. Maintenance & Inspections (Inspections & Testing): Inspect all areas where coating (Standard MT-DTI) has been applied to determine if the coating has any flaking/failure. If flaking/failure have occurred determine if the cause was process related or mechanical damage. Work with impacted Area Business Unit to correct any flaking/failures.

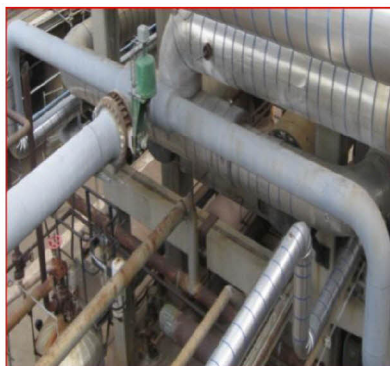
Coating Insulation remains intact .
